REMOVAL AND FINAL STATUS SURVEY OF HISTORIC AVENUE "N" WOOD STAVE PIPE

NAVAL STATION TREASURE ISLAND,
SAN FRANCISCO, CALIFORNIA

BCT Meeting
February 24, 2016

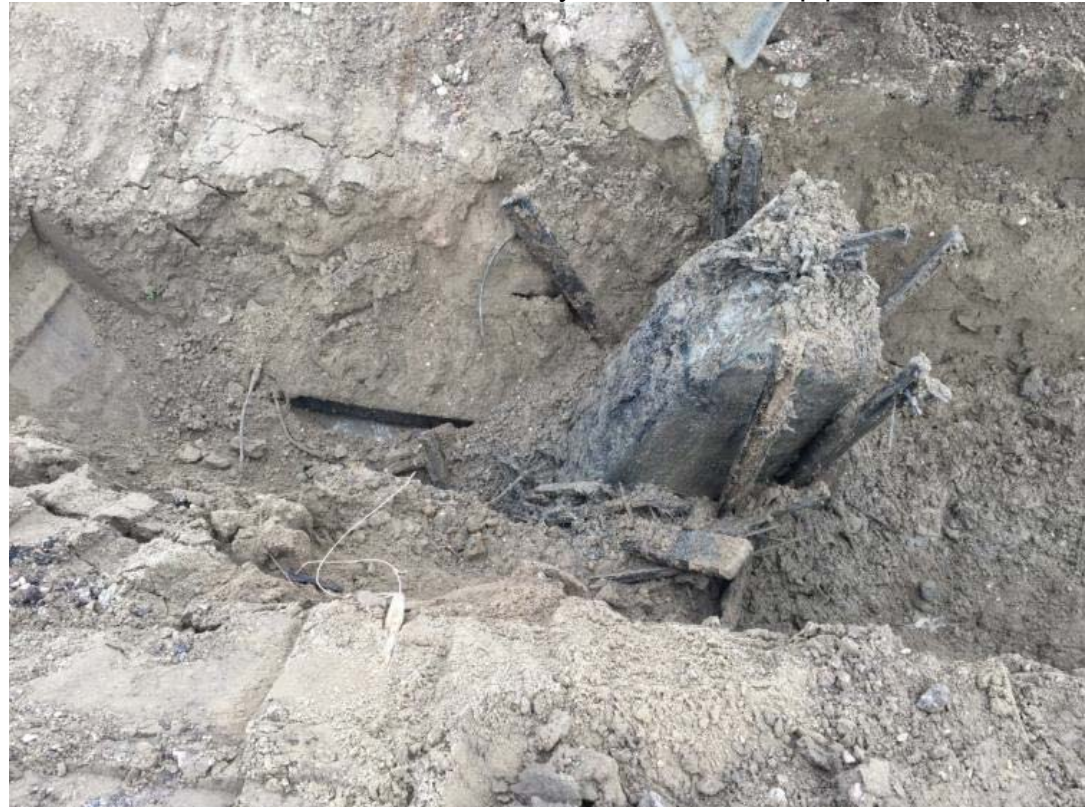
Concrete slurry from within the pipe in Section 5W

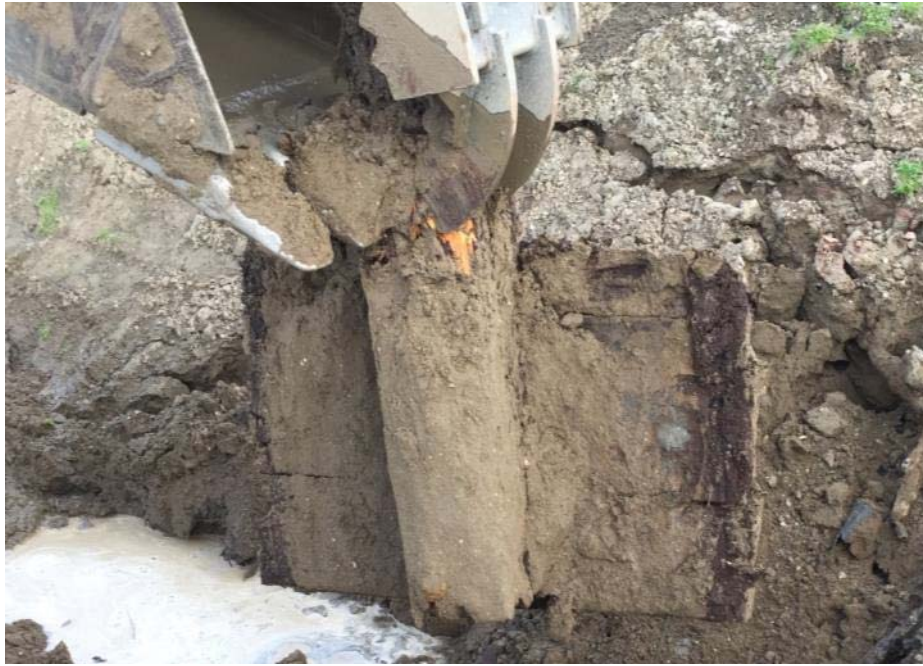
Removed riser and hardware associated with manhole

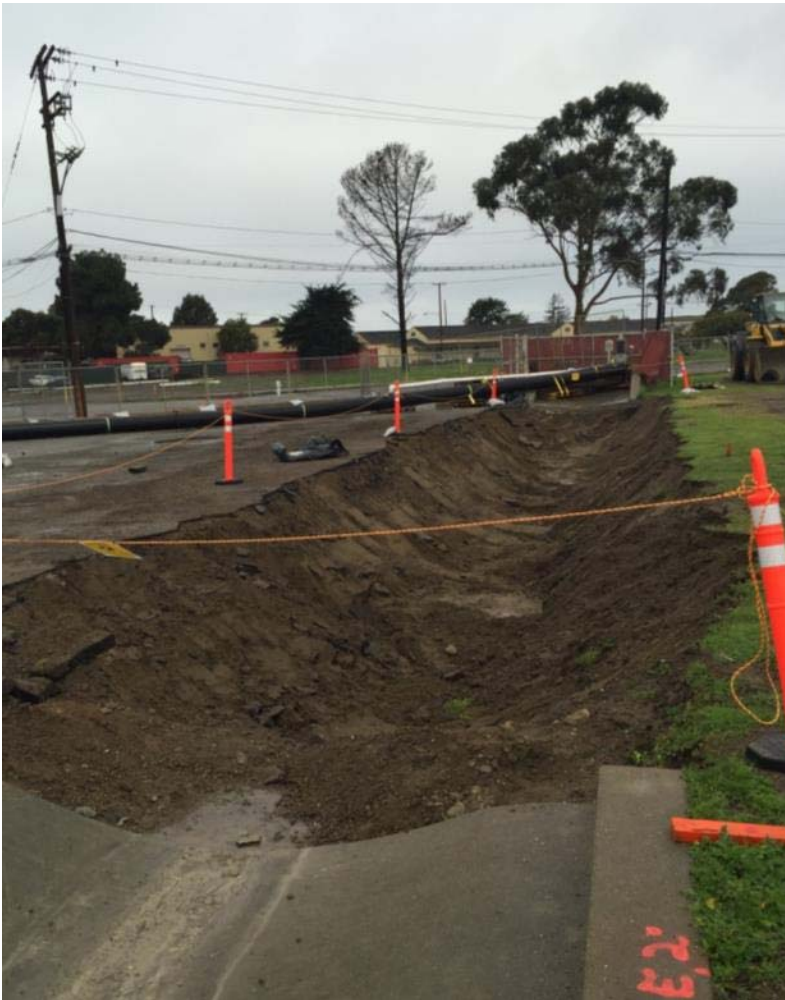
Completed excavation of west end of wood stove

- Soil excavated as overburden was stockpiled on the south side of the excavation
- Radiologically-impacted material was stockpiled within the RCA
- In-process gamma scanning, statics, and smears collected on soil, wood and concrete showed no indication of contamination

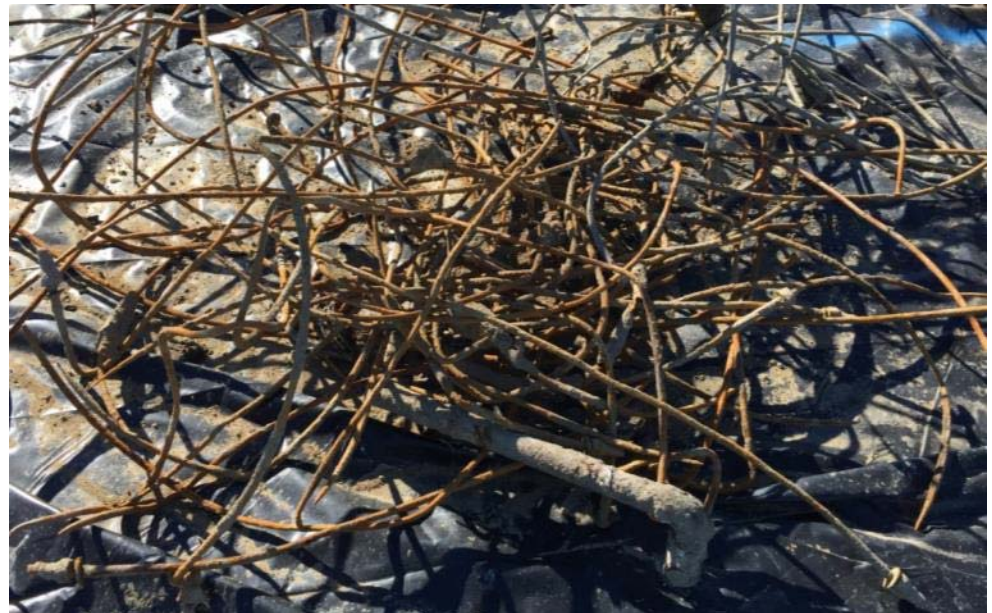
Stockpiled steel bands removed along the length of the excavation

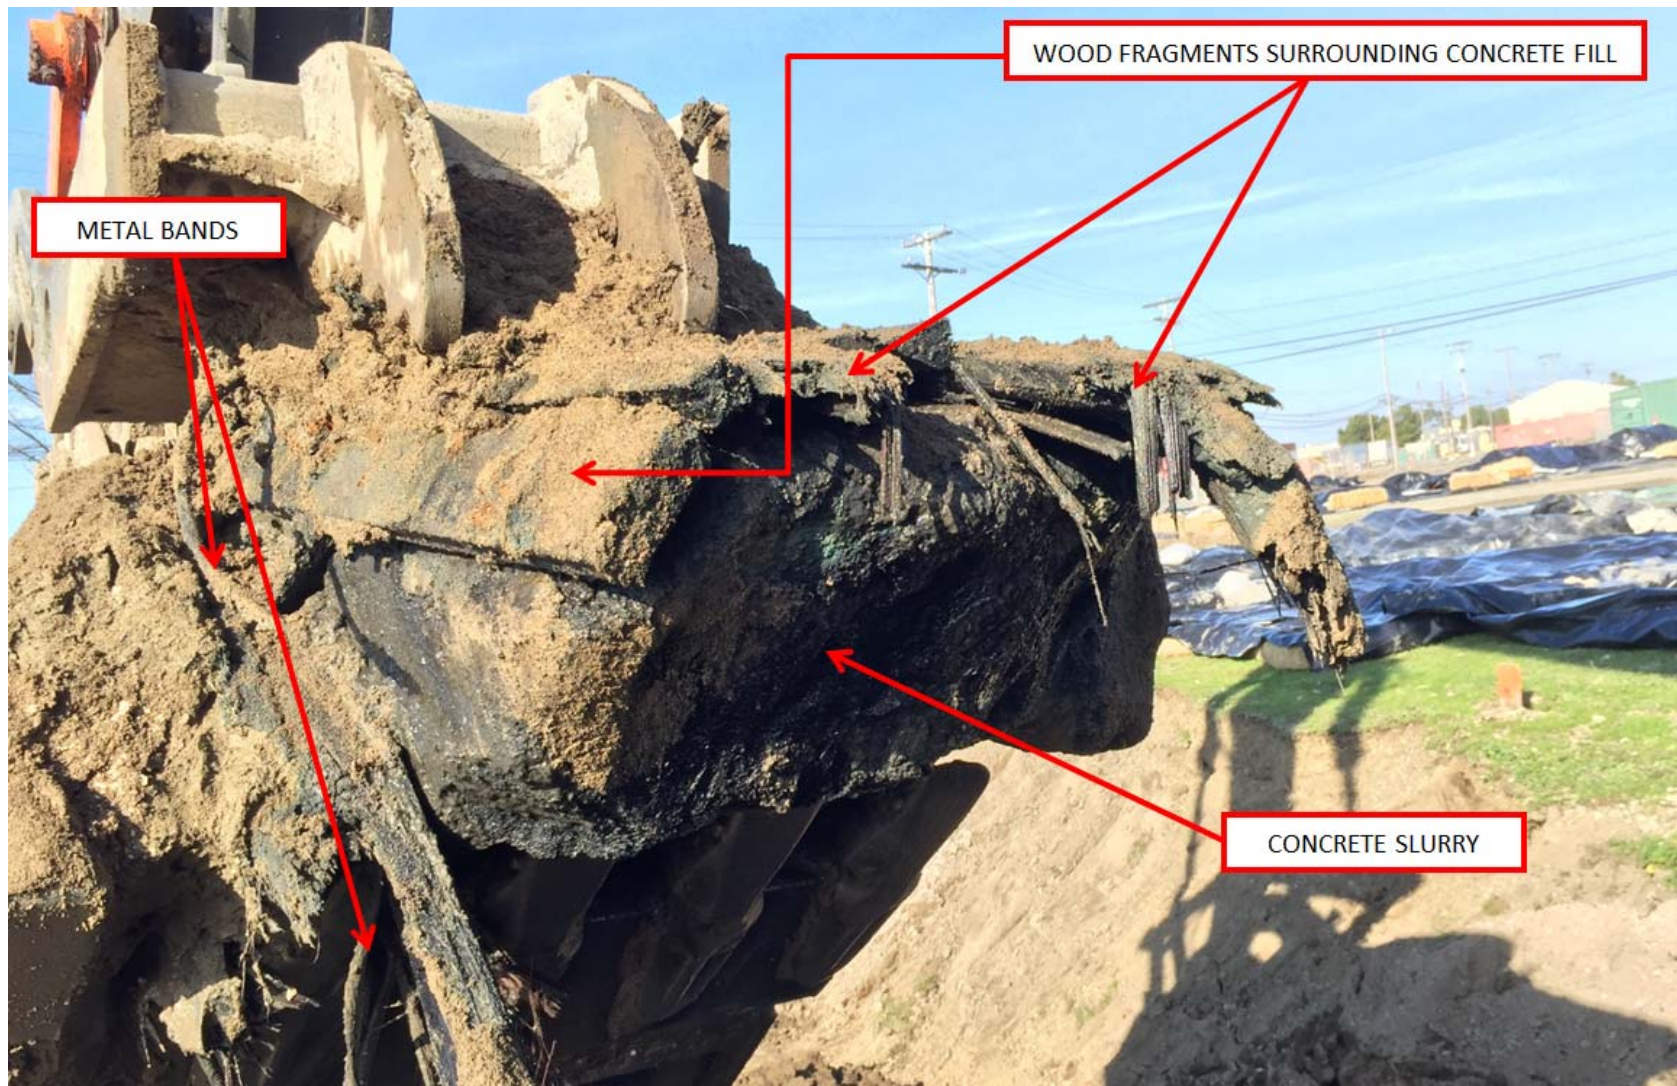
Cross section of the pipe in its current state – concrete surrounds concrete slurry fill. Bands hold together tongue and groove fitted wood planks

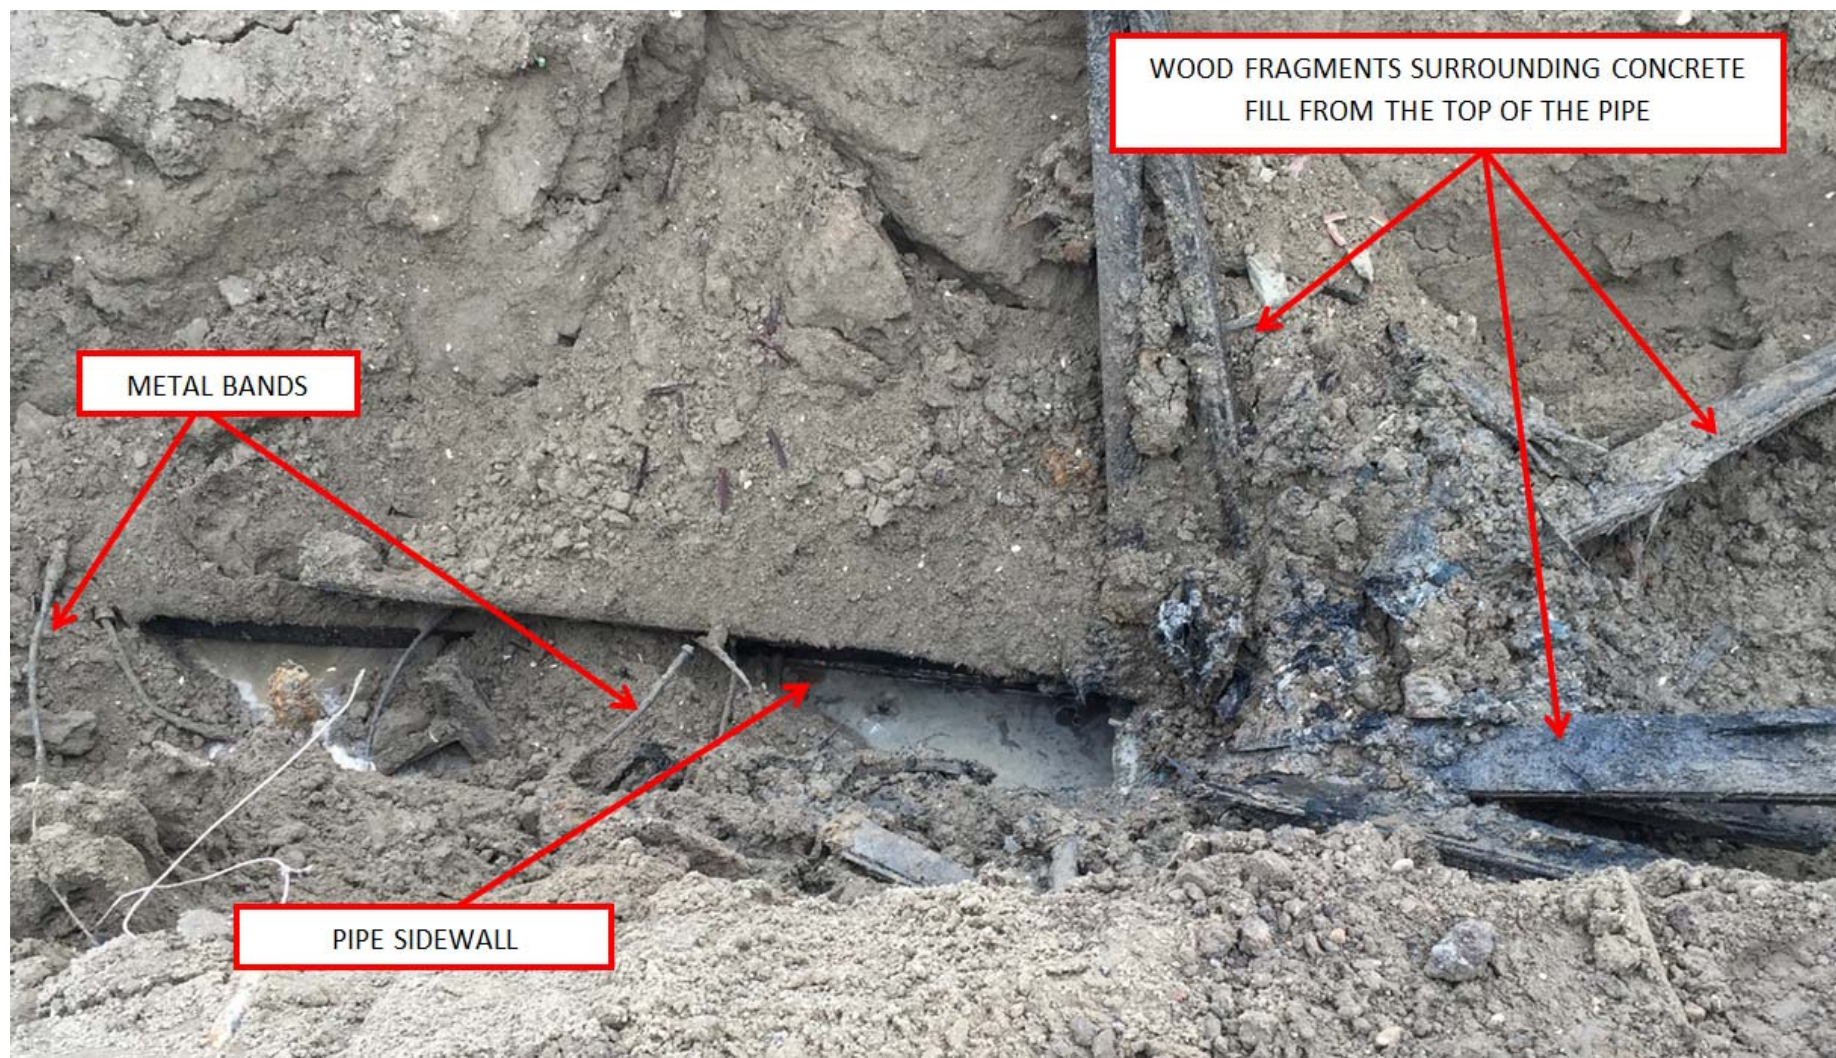
Top view of pipe construction as found in the excavation

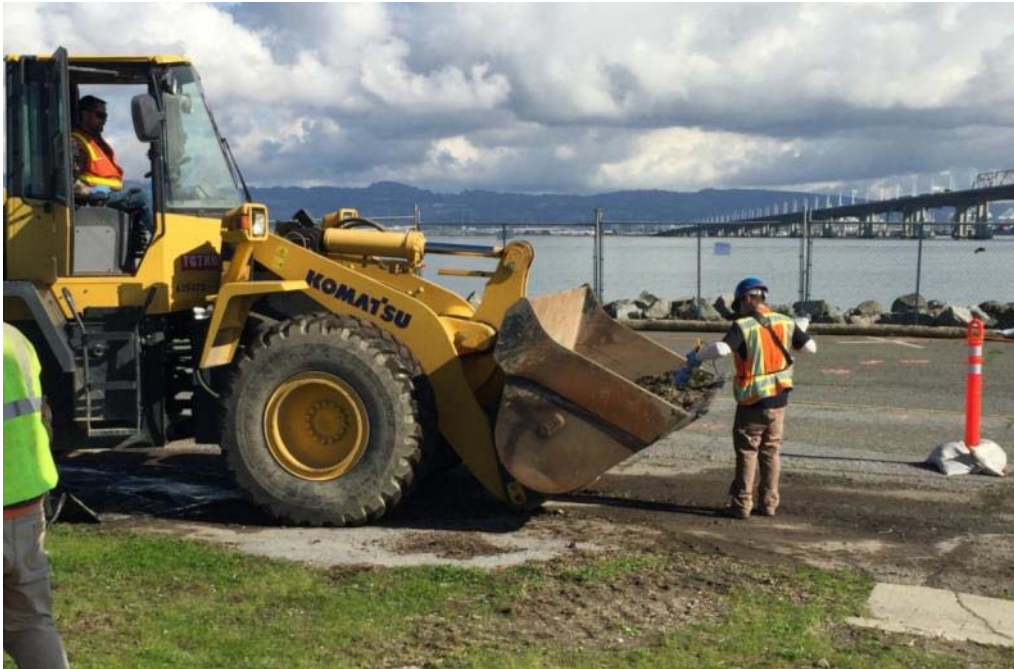
In process gamma scanning of soil removed from Section 1E prior to loading it into RSY 233A

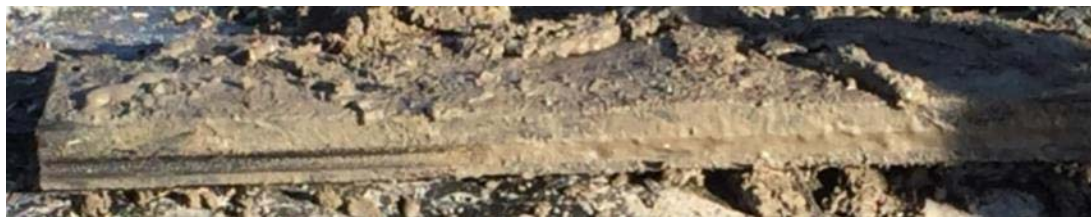
Tongue and groove construction of wooden pipe line

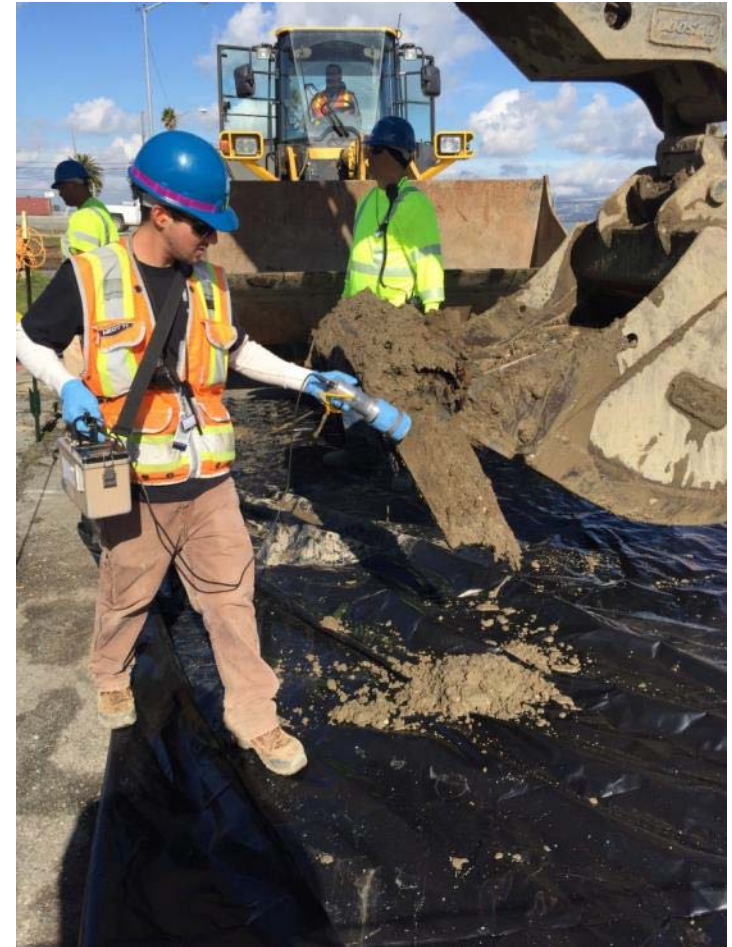
In process gamma scanning of wood fragments from Section 1E prior to separating wood from soil within RCA

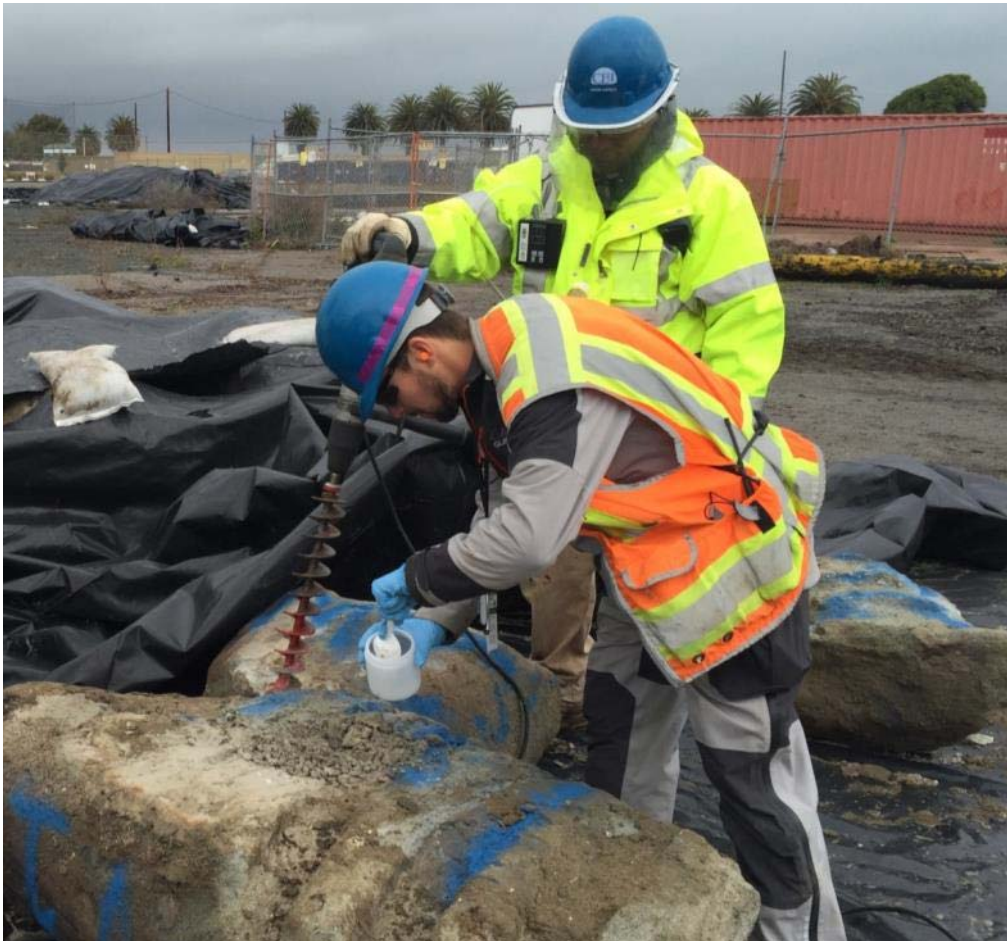
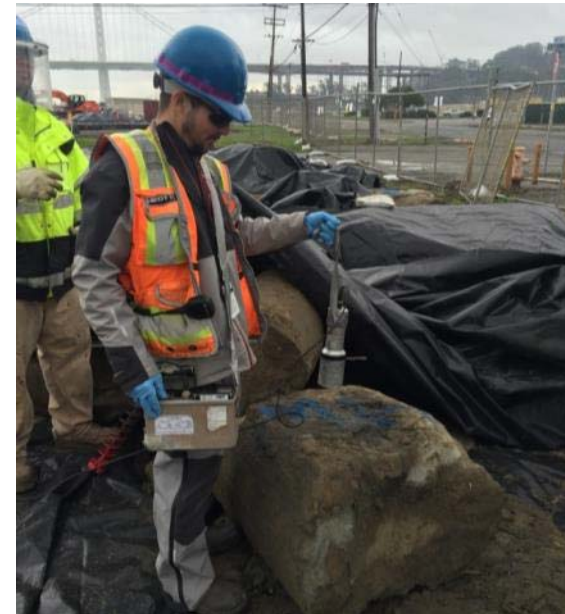
Left and Top Right: sampling concrete for rad and chemical characterization

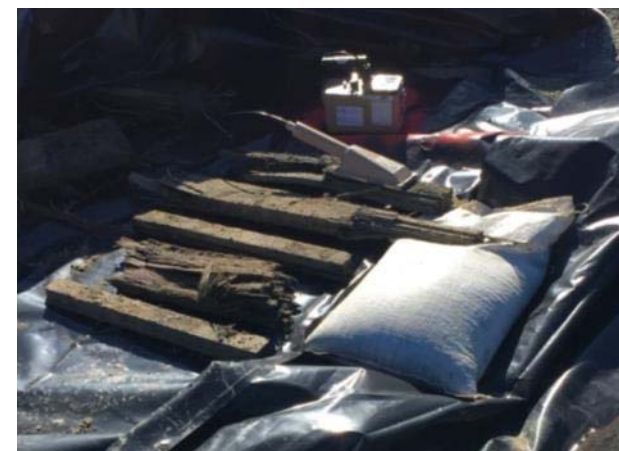
Bottom Right: collecting static readings on wood pieces pulled from the pipe structure for analysis.

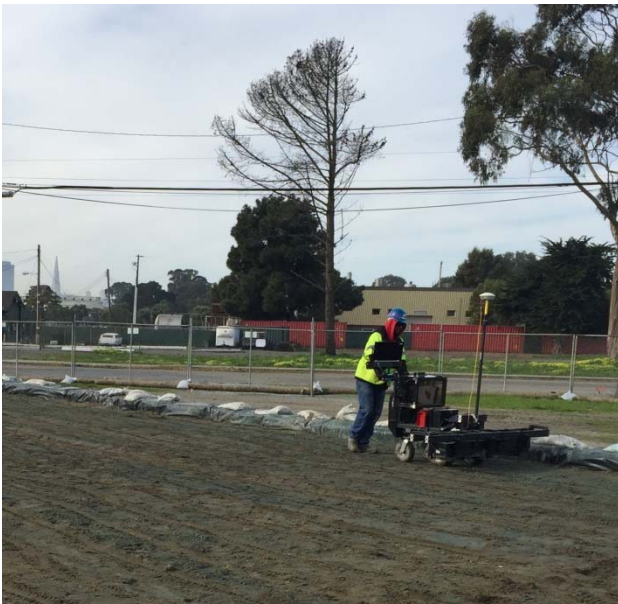
100% Gamma walkover using RS-700

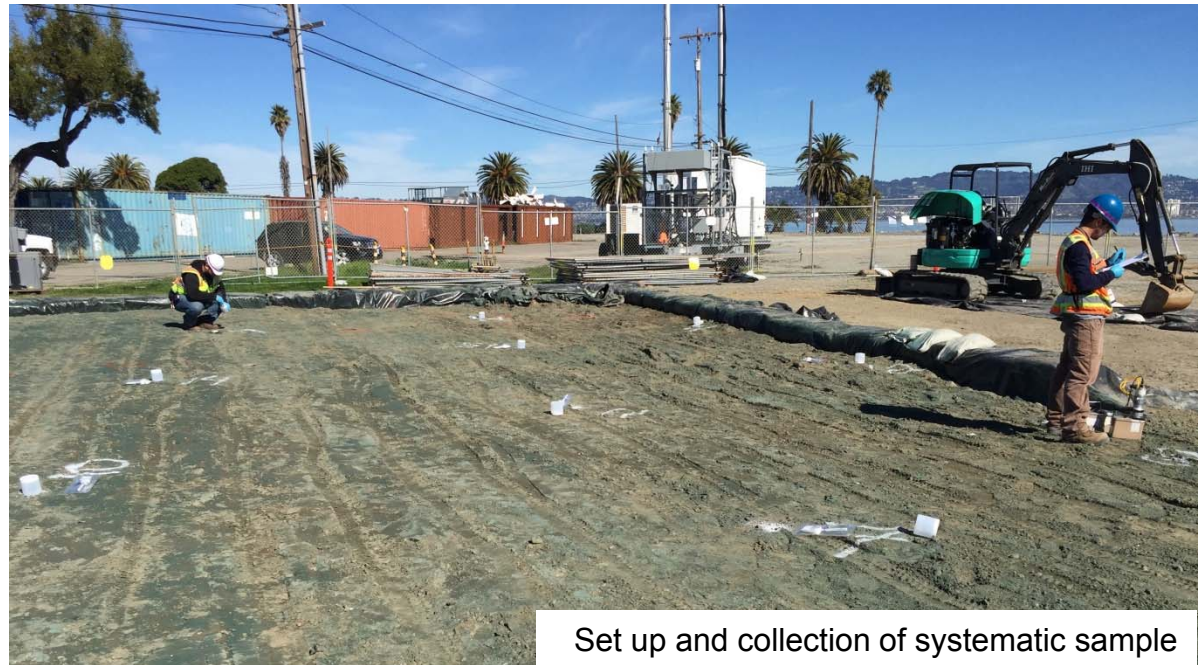
Set up and collection of systematic sample

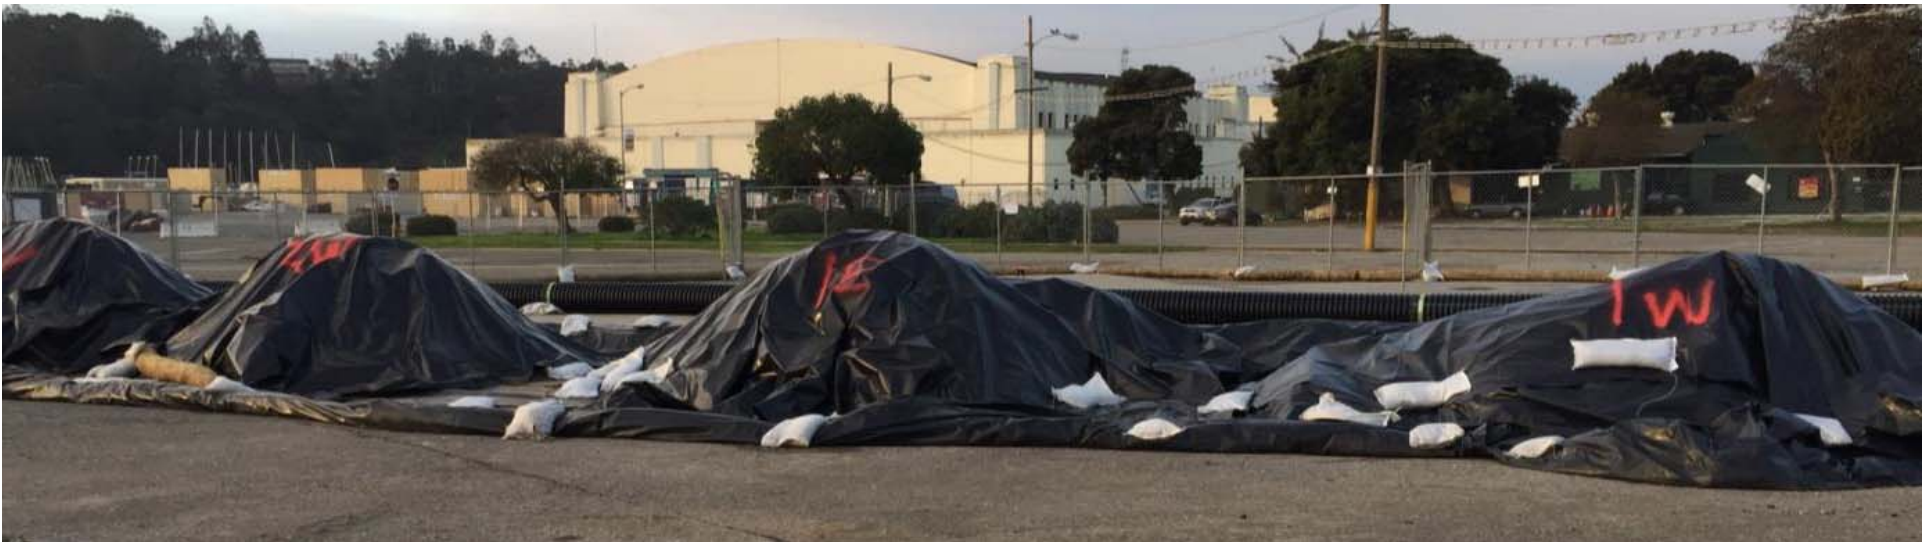
Clean stockpiles along south side of project site.

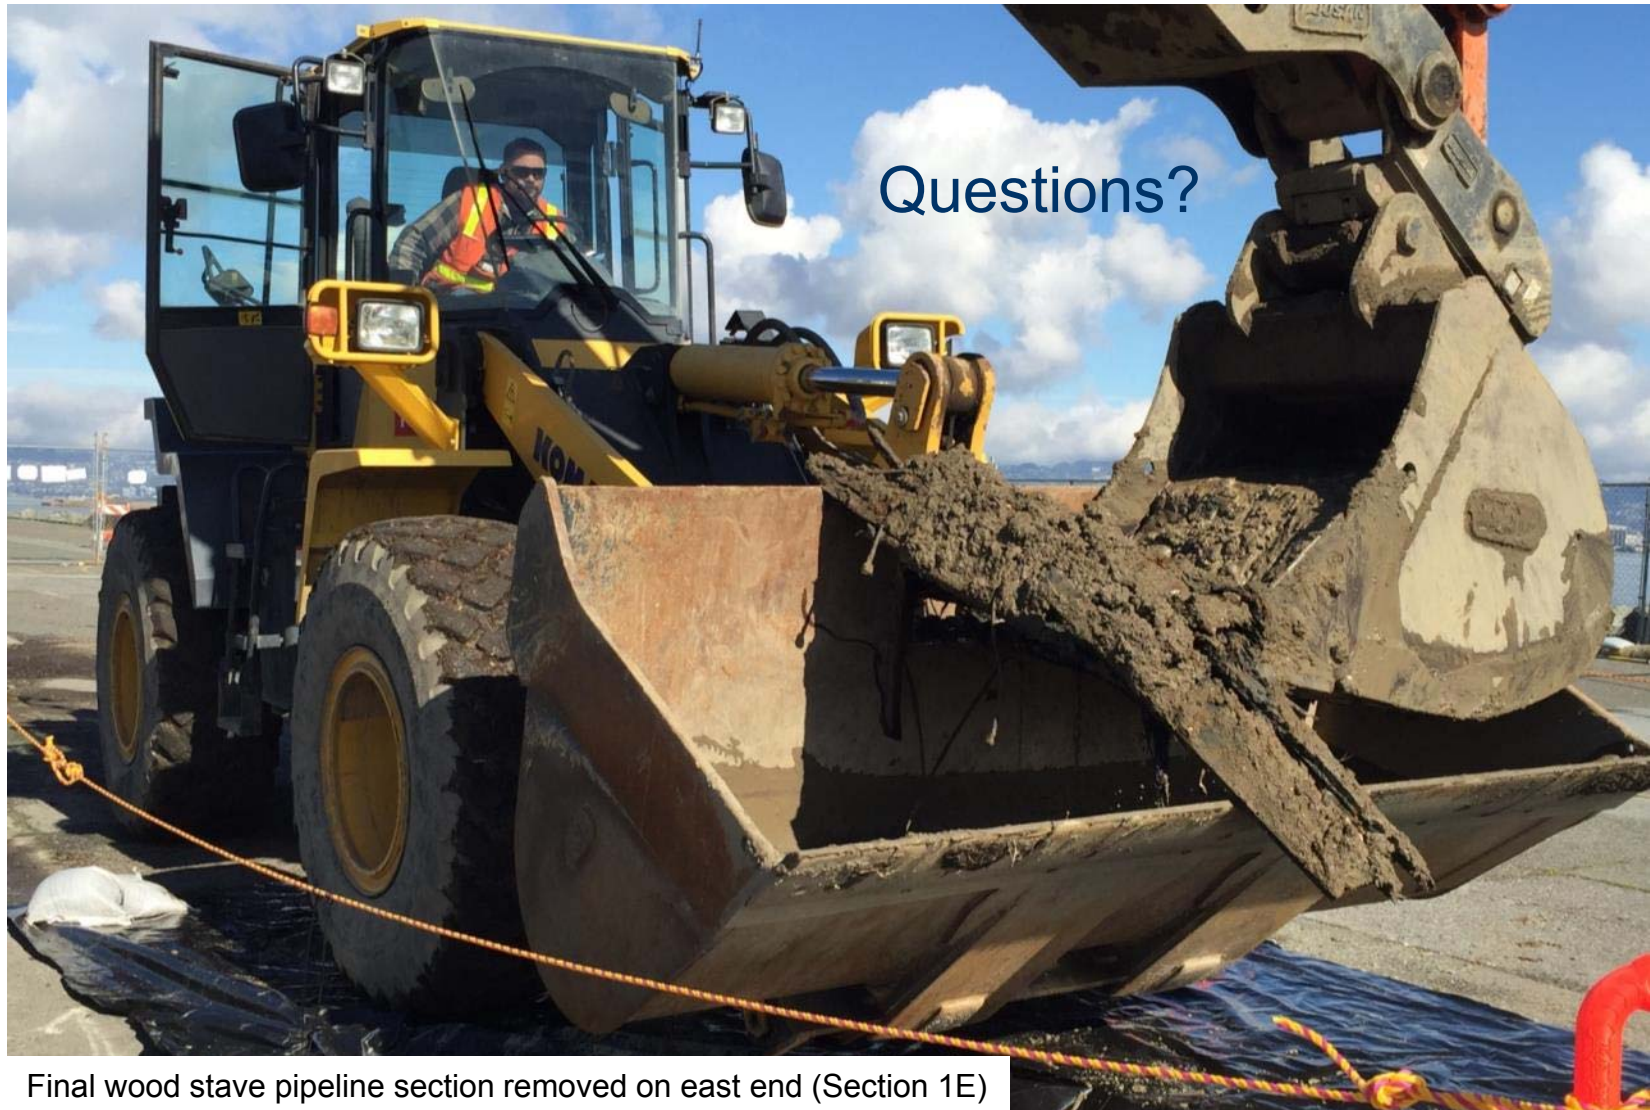
Final wood stave pipeline section removed on east end (Section 1E)
